### REPORT 1019

BULLET-IN-BORE STUDY
OF
5. 56MM, BALL, M193 CARTRIDGE AND M16A1 RIFLE

FRANK E. BRAUN, JR.
AND
ROMAN FEDYNA

October 1969

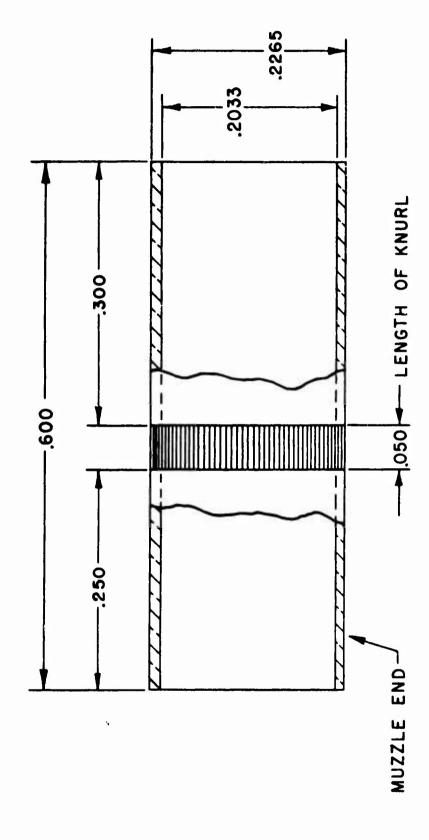
FIGURE 3

Upon examination, it was observed that the wall of the bullet jacket and cannelure were "ironed out" against the bore of the rifle by virtue of the passage of the second bullet through the bullet lodged in the bore (see Figures 3 and 22).

WEIGHT OF RECOVERED BULLET JACKET = 13.557 GRAINS

RECOVERED BULLET JACKET

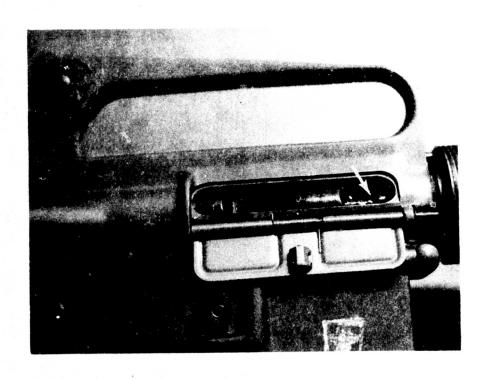
Figure 5. Side view of New Rifle (Serial No. 1326633) with a bullet lodged in the bore, preventing complete chambering of the succeeding round.

Figure 6. Rear view of same condition described in Figure 5.

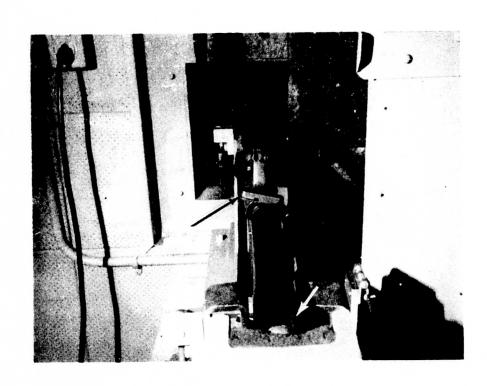
Figure 7. Rear view of damaged Fort Huachuca Rifle (Serial No. 598656) showing cracked rifle stock and twisted charging handle.

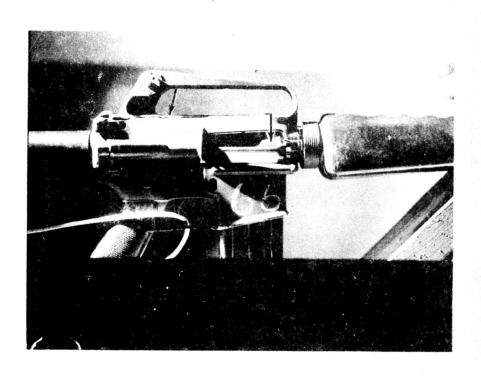
Figure 8. Side view of damaged Fort Huachuca Rifle (Serial No. 598656) showing cracked upper receiver housing.

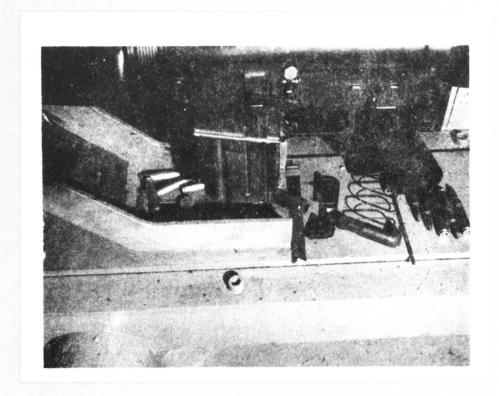
Figure 9. Side view of lower receiver showing auxiliary parts of damaged magazine, cartridges, dust cover and dust cover pin.

Figure 10. Top view showing fractured upper receiver housing and cracked carrying handle.

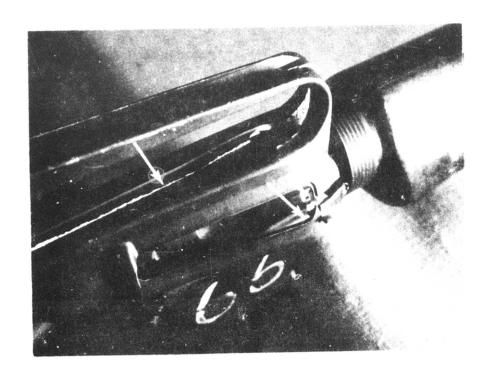
- a. A noncrimped cartridge (modified to simulate tampering) from lot LC 12507 was fired. The bullet lodged in the bore at a position far enough forward of the rifle chamber so that the succeeding cartridge could be chambered in the normal manner without indenting the base of the bullet in the bore. This is typical of the results of previous tests with the Fort Huachuca Rifle. The actual clearance between the base of the lodged bullet and the point of the bullet of the chambered cartridge was approximately .406 inch.
- b. With the bullet in the bore and upon chambering an unmodified LC 12507 cartridge and firing, the weapon was badly damaged around the upper receiver (splitup to and along the carrying handle) and magazine areas (see Figures 7 through 20). The disassembly of the weapon revealed a bulged magazine housing (see Figure 12), a damaged magazine with three damaged cartridges

Figure 11. Side view showing fractured upper receiver housing, cracked carrying handle and closed bolt.

Figure 12. Bottom view showing bulged magazine housing, damaged magazine and auxiliary parts.

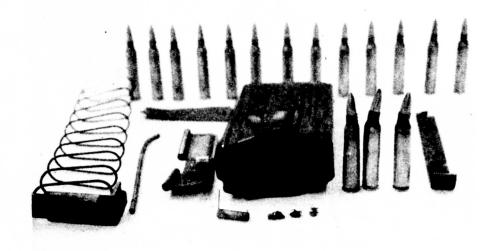
which were blown from the magazine and found on the floor of the gun-mounting fixture (see Figure 13), a fractured bolt carrier (see Figure 18), a bent and broken extractor (see Figure 17), a crack in the wall of the barrel through the locking lugs (see Figure 20), a ruptured cartridge case which was lodged in the chamber, and a bullet jacket if found in the bullet seat when removing the ruptured cartridge case. The recovered bullet jacket weighed 13.557 grains. The nominal weight of a normal bullet jacket is 17.000 grains.

Figure 13. View showing recovered magazine, auxiliary parts and cartridges. Note three damaged cartridges.

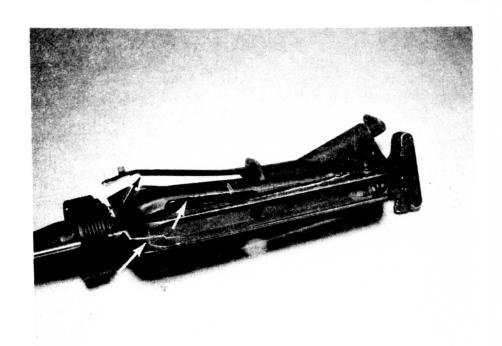
Figure 14. Top view showing fractured upper receiver housing.

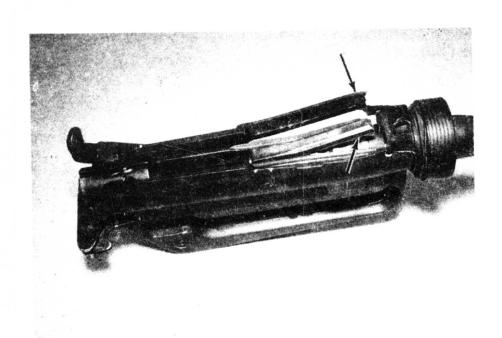
Figure 15. View showing fractured upper receiver housing and bolt carrier.

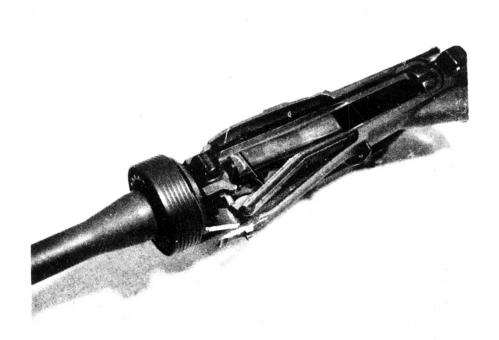
Figure 16. Bottom view of same condition described in Figure 15.

Figure 17. View showing undamaged bolt and bent extractor.

Figure 18. View showing fractured bolt carrier.

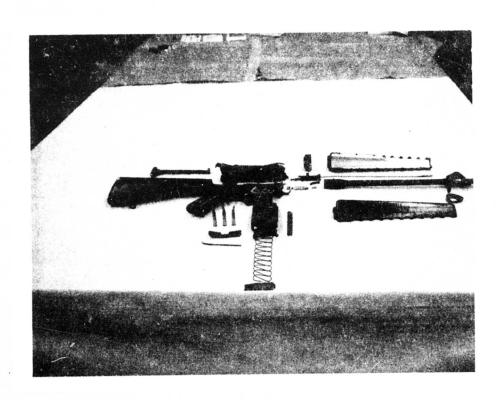
Figure 19. View showing disassembled parts of damaged weapon.

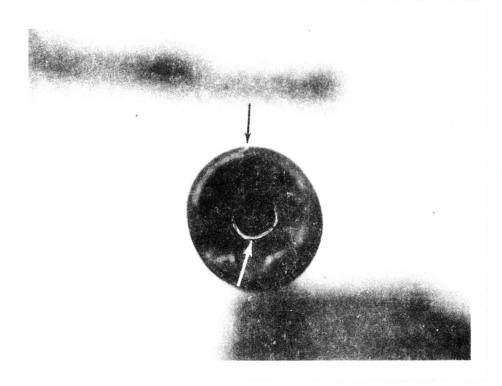
- i The raptured cartridge case was that of the succeeding cartridge that was chambered completely and fired into the lodged bullet in the bore (see Figures 20 and 21).
- It is theorized that this bullet jacket was from the lodged bullet in the bore.

Figure 20. View showing crack in wall of barrel extending through locking lugs and body of a cartridge case. (Case head was sheared off during weapon disassembly.)

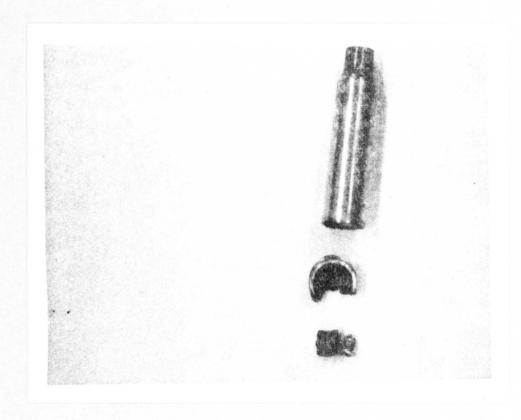
Figure 21. View showing body of cartridge case after removal from the chamber. The smaller portion of the case head was pulled off by the extractor when the weapon was fired.

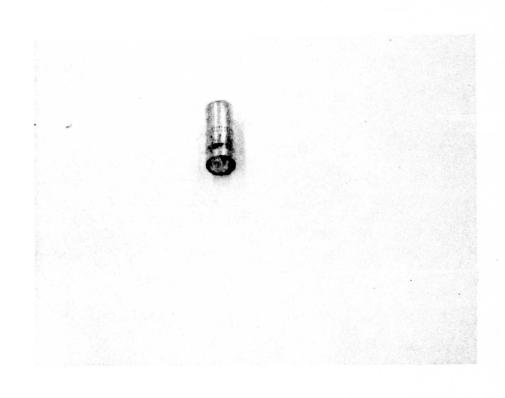
Figure 22. View of partial bullet jacket removed from bullet seat.

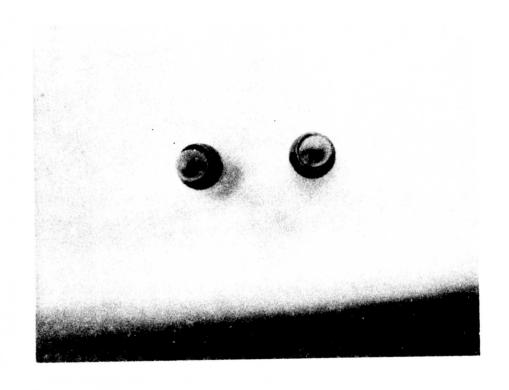
Figure 23. View showing two uncrimped cartridges.

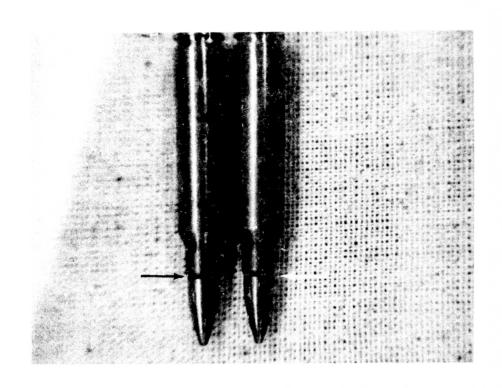
Where modified cartridges failed to produce bullet-in-bore type malfunctions, chambered cartridges elongated as much as .012" beyond the maximum allowable cartridge length due to pressure from the primer (see Figure 24). Exact original lengths of cartridges were not determined although the lengths after hand crimping were gaged for acceptability with a "Go/No-Go" gage.

Figure 24. View showing two modified cartridges after extraction.

An observation of the cannelures shows one cartridge which elongated upon firing and a second cartridge which did not elongate upon firing.

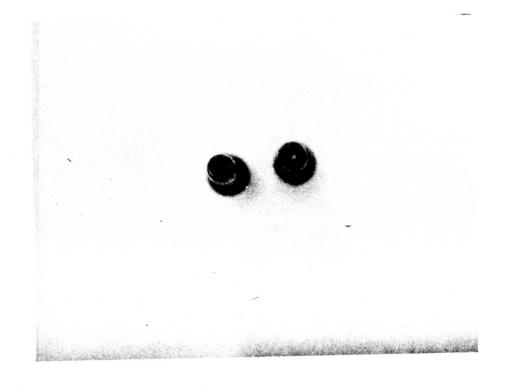
Figure 25. View showing two bullets after removal from the bore of the weapon. One shows no indentation at the base while the other shows an indentation made in attempting to chamber the succeeding round.

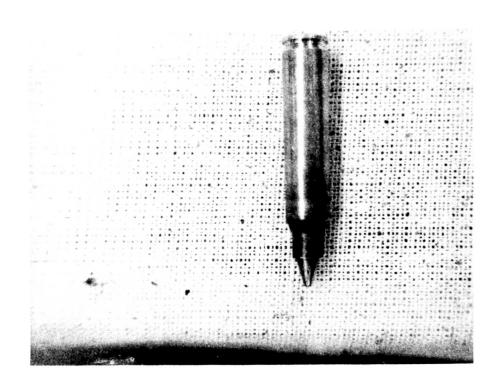
- (3) New Rifle the total number of bullets lodged in the bore was 27. With one exception (see Figure 26), no succeeding rounds could be chambered due to excessive resistance (procedure described in Appendix A).

Figure 26. View showing the telescoping of an unmodified cartridge from an attempt to chamber it behind a bullet in the bore of the weapon.
